TENNESSEE STATE DEPT OF CONSERVATION NASHVILLE DIV 0--ETC F/G 13/17
NATIONAL PROGRAM OF INSPECTION OF NON-FEDERAL DAMS, TENNESSEE. --ETC(U)
JUL 81 W CULBERT
DACW62-81-C-0056
NL

Lever Lake Dam
Williamson County
April 2, 1981

PHASE I INSPECTION REPORT
NATIONAL DAM SAFETY PROGRAM
TENNESSEE

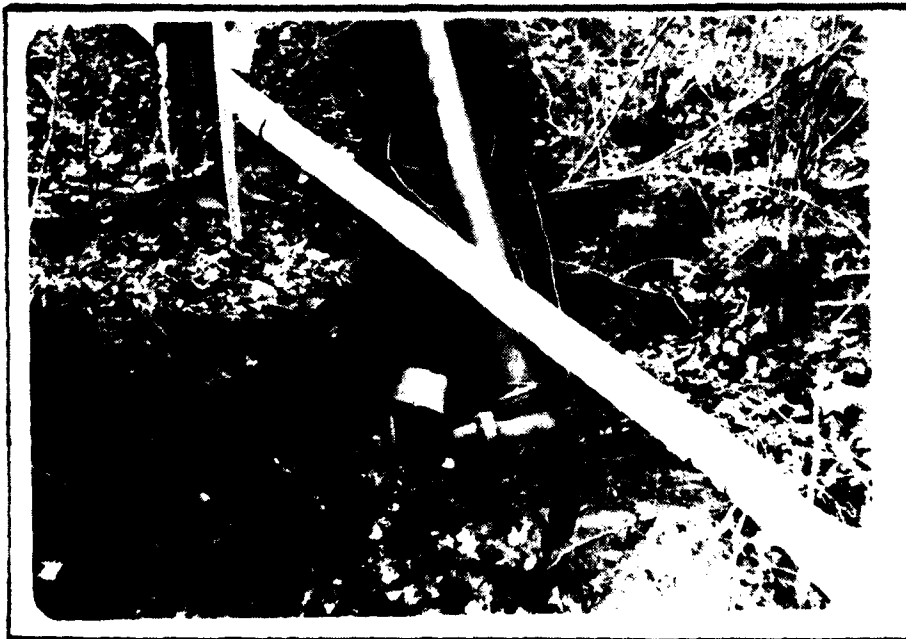
PHOTO NO. 6

The concrete culvert drawdown leaks approximately 2 gpm. Whether the flow is from a leak at the inlet or from infiltration through the culvert could not be ascertained. (See photo nos. 6 and 7)
